Annual CCR Unit Inspection Report

Lon D. Wright Power Plant
Fremont, Nebraska

Prepared for
Fremont Department of Utilities

January 19, 2016

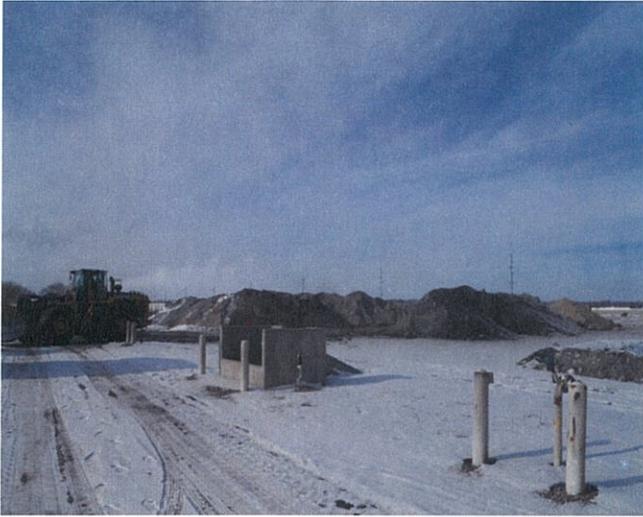
During the inspection, a truck hauling CCR unloaded its contents onto the southwest portion of the lined area and was further managed by a front-end loader (see Photograph #1). Minimal dust was generated and no fugitive dust was observed leaving the property boundary.

Photograph #1 1/5/16
Photograph taken facing northwest on access road between south end of monofill lined area and the leachate collection pond. The concrete object in the lower center of the photo is the leachate riser. The CCR in the background is staged on the liner for potential beneficial use or disposal.

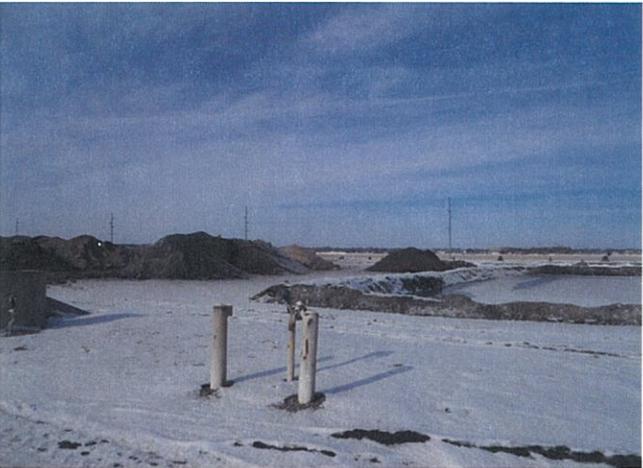
Photograph #2 1/5/16
Photograph taken from same location as previous photo but in a northerly direction. The object in the foreground is part of the Hydrovactor system. The active disposal area is shown towards the right of the photo.

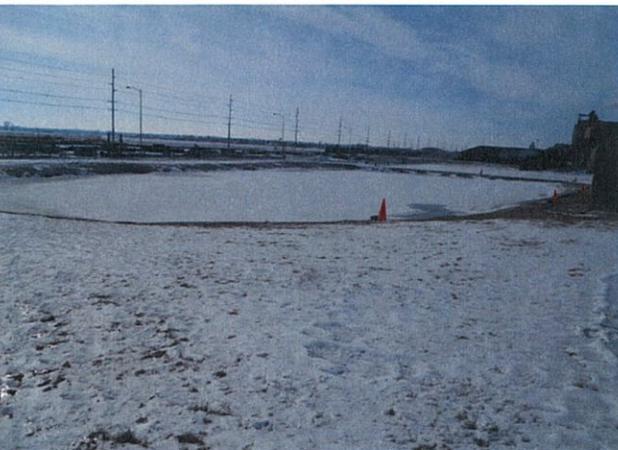
Photograph #3 1/5/16
Photograph taken facing southwest showing the leachate collection pond. Ice had formed and snow collected on the surface. The orange cones are placed next to rodent bait traps.

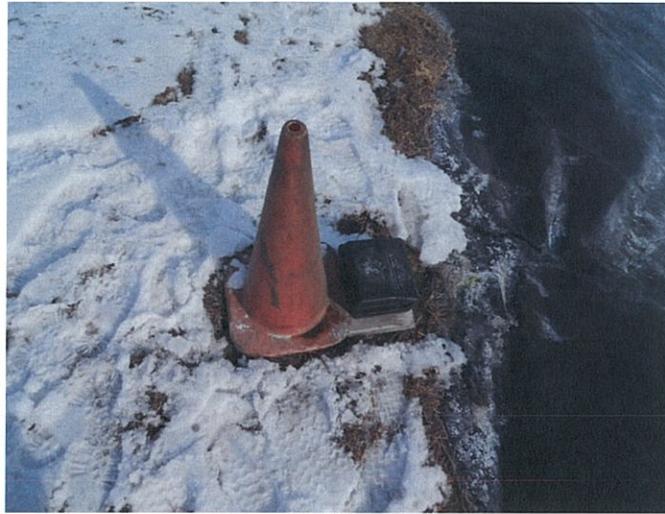
Photograph #4 1/5/16
Close-up view showing an orange cone and associated bait trap for rodents. The leachate pond liner can be seen to the far right of the photo.

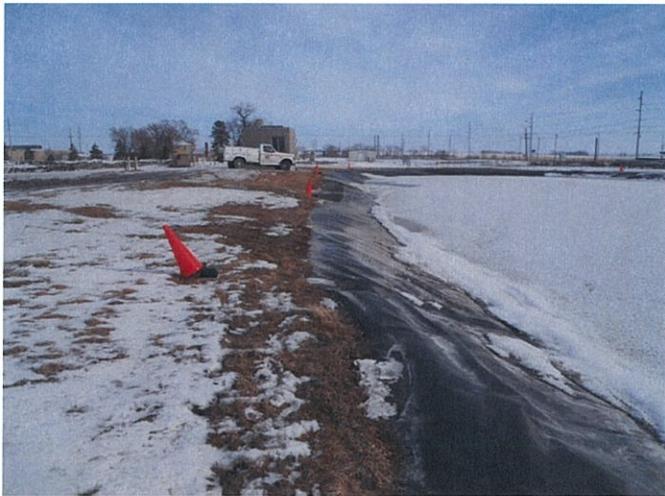
Photograph #5 1/5/16
Photograph taken facing east showing the northern edge of the exposed leachate collection pond liner. Ice and snow covered the surface of the leachate pond. Orange cones with rodent bait traps can be seen along the lip of the liner.

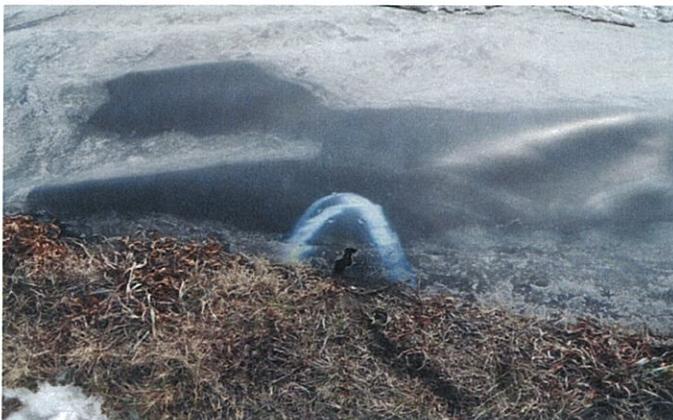
Damage to the liner was noted during the inspection process as well as observed and discussed with NDEQ representatives at the time of the CCR Unit permit renewal inspection conducted November 16, 2015. Damage to the upper edge of the leachate collection pond apparently by rodents, has resulted in several holes through the liner. Pest control measures are in place and should continue to be implemented to eradicate the pest and allow for repair of the liner. NDEQ representatives supported FDU's effort of using bait boxes to control the pest and to subsequently repair the liner.

Photograph #6 1/5/16
Close-up view showing damage caused by rodents to the upper edge of the leachate collection pond liner.

1. FDU should continue to be diligent about eradicating pests that have caused damage to the upper portion of the leachate collection pond liner and repair the damage to the liner in an expeditious manner.

Recommendations: FDU should continue to be diligent about eradicating pests that have caused damage to the upper portion of the leachate collection pond liner and repair the damage to the liner in an expeditious manner. NDEQ has requested notification to the department subsequent to completing the repair to the liner. FDU should continue to consult with a pest specialist to ensure control measures are appropriate. No other conditions were observed that indicated any structural weakness, change in geometrical design, or a disruption in operation and safety of the leachate collection system.

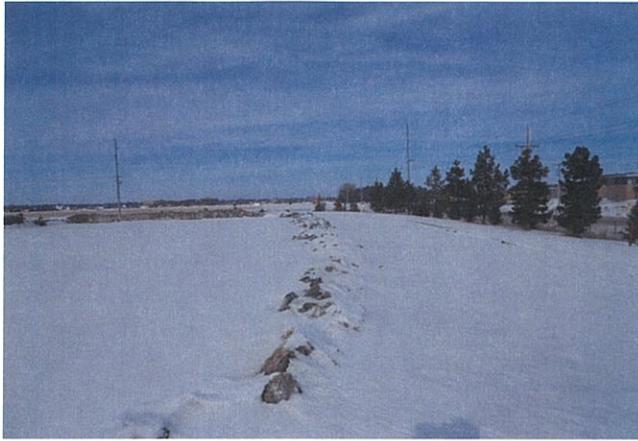
Photograph #10 1/5/16
Photograph taken facing north from the same location as the previous photo. The snow covered berm can be seen in the center of the photo and the lined disposal area is shown to the left of the photo.

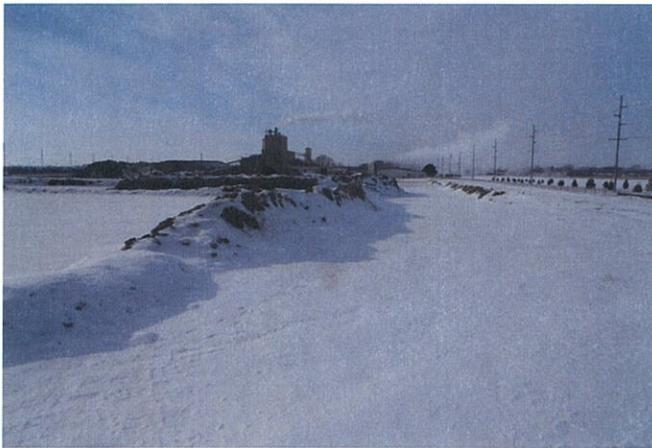
Photograph #11 1/5/16
Photograph taken facing west from the northeast corner of the monofill. The berm and monofill are shown to the left of the photo.

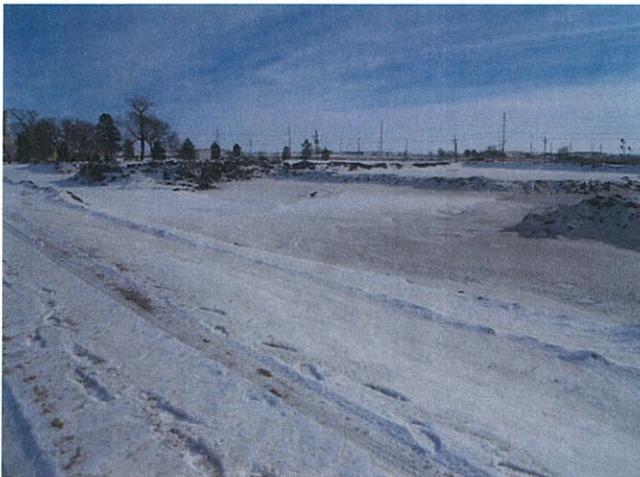
Photograph #12 1/5/16
Photograph taken facing southeast from the north side of the monofill. The lined disposal area is shown in the center of the photo.

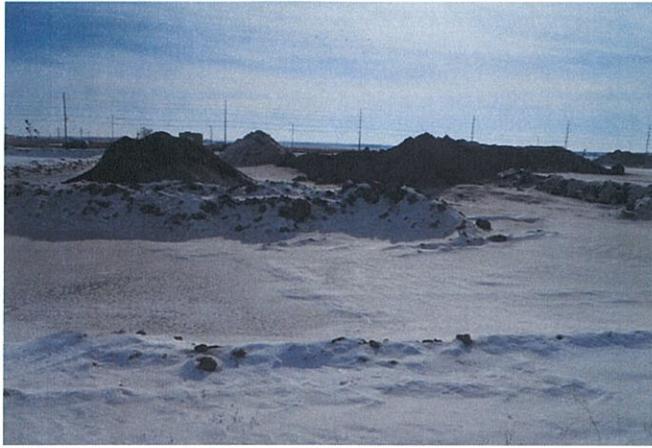
Photograph #13 1/5/16
Photograph taken facing south from the same location as the previous photo. CCR staged on the liner can be seen in the top half of the photo. This material is staged for potential beneficial use purposes.

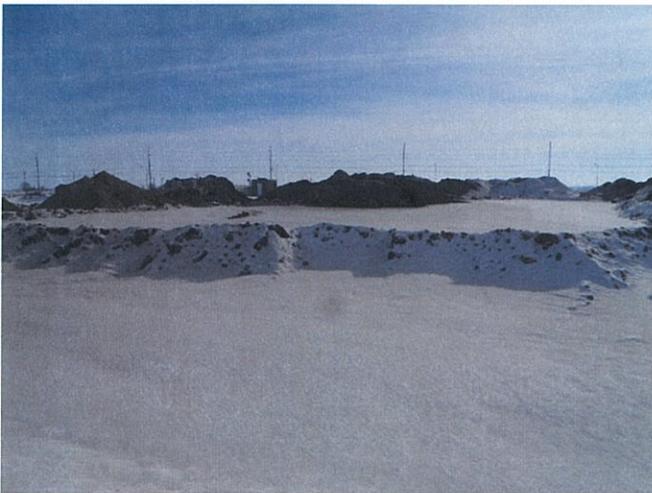
Photograph #14 1/5/16
Photograph taken facing south from the northeast corner of the monofill. The CCR material shown was placed within the lined area.

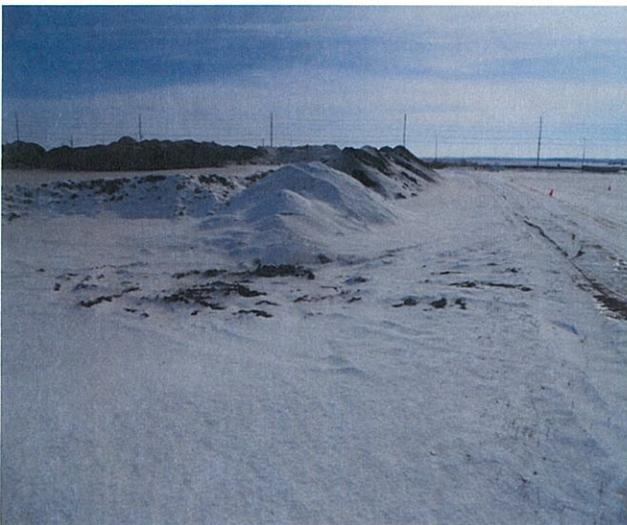
Photograph #15 1/5/16
Photograph taken slightly west of the location in the previous photo and facing south. The CCR material was placed on the liner. The access road to the right of the photo is the west boundary of Phase I. The Phase II area can be seen to the far right.

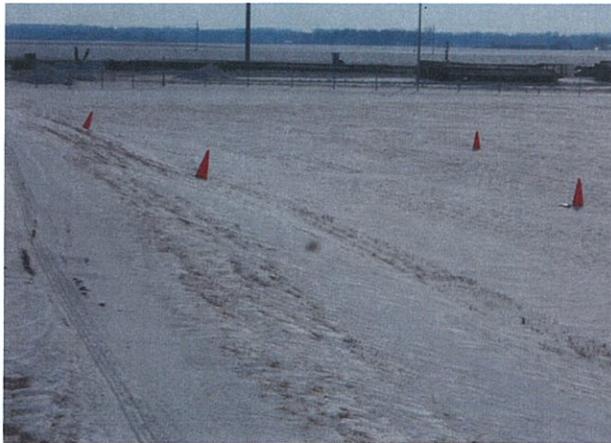
Photograph #16 1/5/16
Close-up view of the Phase II area shown in the previous photo. The berm (access road) is shown to the far left. The orange cones are used to locate rodent bait traps in place to eliminate future damage to the top of the leachate liner.

Recommendations: Although Phase II construction has not been initiated, FDU should continue to monitor animal burrows throughout the CCR Unit footprint and backfill any suspected animal dwellings. Tetra Tech supports FDU's action of expanding rodent control bait stations into the Phase II area (see Photograph # 16). No other conditions were observed that indicated any structural weakness, change in geometrical design, or a disruption in operation and safety of the Phase I berms and Phase II area.
