Annual CCR Unit Inspection Report

Lon D. Wright Power Plant
Fremont, Nebraska

Prepared for
Fremont Department of Utilities

March 20, 2017

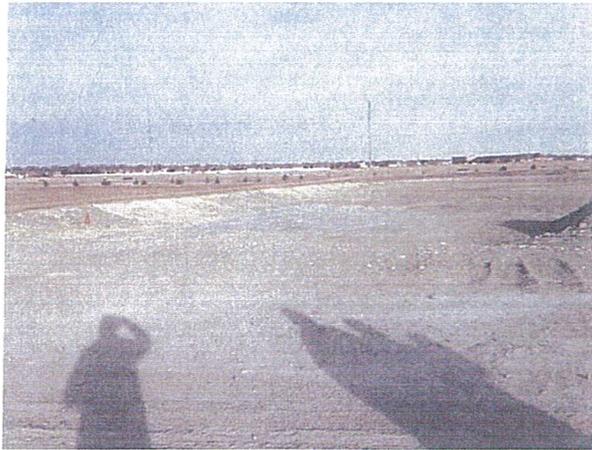
Photograph #1 1/4/17
Photograph taken facing
northwest on access road between
south end of monofill lined area
and the leachate collection pond.

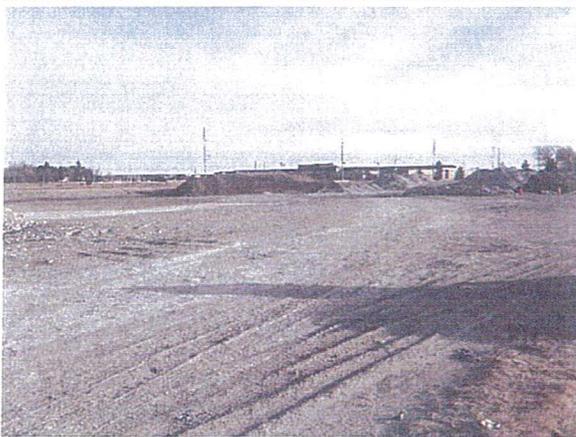
Photograph #2 1/4/17
Photograph taken from same
location as previous photo but in a
northeastern direction. CCR
material shown in the background is
staged for beneficial use with the
exception of the brown material in
the background center of the photo,
which is bottom ash staged for
disposal at the municipal landfill.

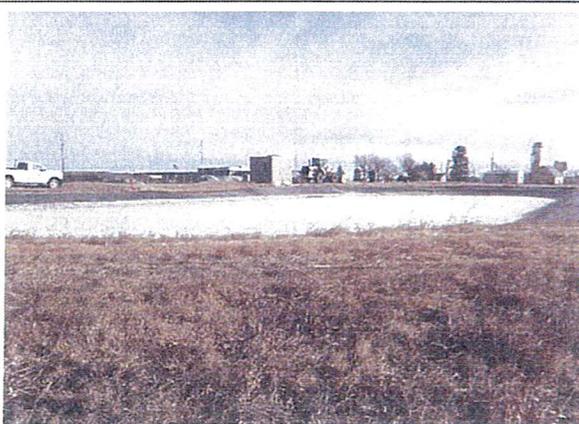
Weather conditions resulted in the leachate pond being frozen and inhibited observation of the leachate to visually evaluate for abnormalities such as discoloration or accumulation of CCR solids within the containment. The depth of the leachate was not measured but there was sufficient capacity remaining between the pond level and the top of the liner. Damage by rodents to the upper portion of the liner observed during the January 5, 2016 annual inspection were repaired and no further damage to the upper portion of the visible liner was observed (see photographs #4 through #6). Rodent bait traps continue to be in place along the top edge of the liner. At each bait station location there were orange safety cones sitting on top of plastic rodent bait traps. As required, written notification to NDEQ by FDU was provided August 16, 2016, verifying the repair on August 1, 2016, of the damaged leachate liner.

Photograph #3 1/4/17
Photograph taken facing southwest
showing the leachate collection
pond. Ice had formed on the water
surface.

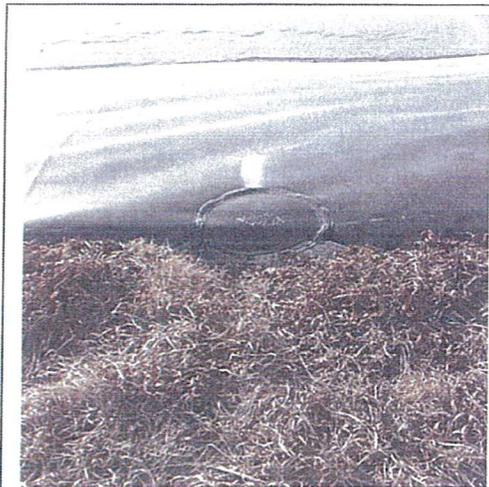
Photograph #4 1/4/17
Close-up photograph showing the repair of the leachate collection pond liner that was previously damaged by rodents.

The large burrows were inspected by Pest Pros and believed to be from hibernating skunk or groundhog. As of 2016 the burrows appear to be abandoned. The pond liner was repaired on 8/1/16.

- **Description of Action Required:** *Rodents believed to be ground squirrels that chewed four to five holes along the edge of the detention pond liner. Pest Pros was hired and placed bait traps near burrows and along animal tunneling locations. The bait traps were placed at these locations on May 15, 2015. It will take an estimated two to three months to completely eradicate the rodents. Once the rodents have been eradicated, the liner will be repaired.*
- **Date Control Measure Returned to Full Function:** *August 2, 2016*
- **Justification for Extended Schedule, if applicable:**

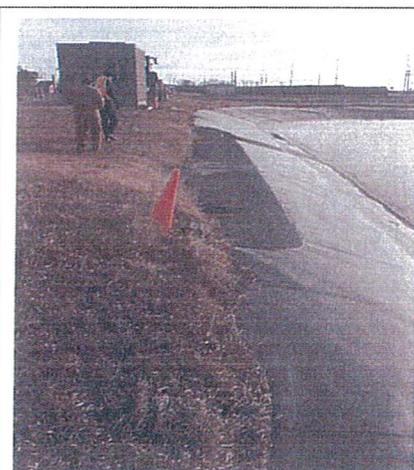
Photograph #5 1/4/17
Photograph taken facing east showing the northern edge of the exposed leachate collection pond liner. Ice covered the surface of the leachate pond. Orange cones with rodent bait traps can be seen along the lip of the liner. The liner has been repaired and no evidence was observed of further damage by rodents.

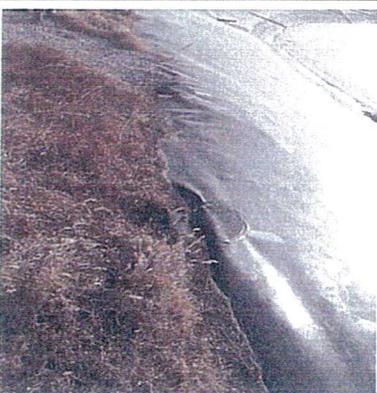
Photograph #6 1/4/17
Close-up view showing another area of leachate pond liner repair.

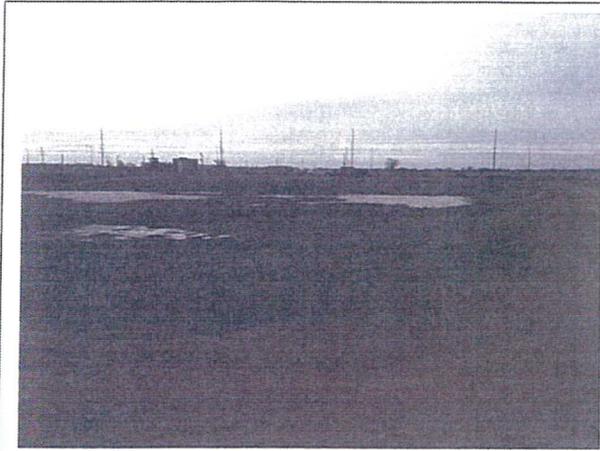
Condition of the Phase I berms and Phase II area were evaluated for erosion, vegetative cover, signs of structural failure, animal burrows, and any abnormalities (see Photographs #1, 2, 7, and 8). Tetra Tech did not observe any abnormal conditions or issues that warrant corrective action. This position is supported by the results of the October 26, 2016 NDEQ unannounced inspection of FDU's ash disposal operations, whereby no violations or concerns were noted. The slope and condition of the berms were observed by Tetra Tech to be in good condition and no obvious indication of animal burrows or signs of erosion or lack of vegetation.

Photograph #7 1/4/17
Photograph taken facing south showing the CCR unit phase I berm.

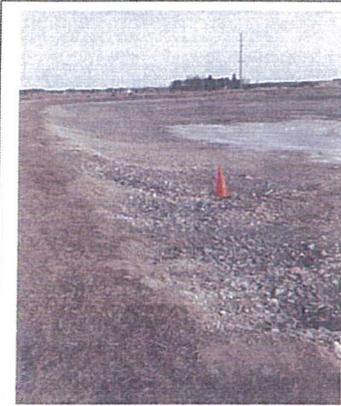
Mr. Sedlacek explained and showed the area designated by an orange safety cone where repair was made to a damaged portion of the CCR unit liner by a back hoe (see photograph #8). Documentation was provided including a letter dated October 18, 2016, to NDEQ notifying the agency that the liner was damaged and repaired in a timely manner.

Photograph #8 1/4/17
Photograph taken facing north showing the west berm of the phase I disposal area. The orange safety cone indicates the area where the liner was damage by a back hoe. The liner has since been repaired.

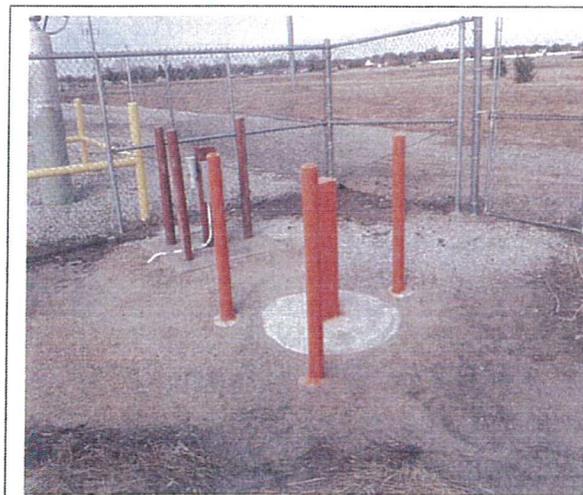
Also identified in the previous annual report was the upheaving of Ground Water Monitoring Well #4. This well was abandoned and replaced with a new #4 monitoring well (see Photograph #9). In addition, based on the recommendations of FDU's "Groundwater Monitoring System Assessment," dated January 28, 2016, three additional wells were installed to improve detection of a release and analysis of ground water constituents.

Photograph #9 1/4/17
Photograph showing the new active ground water monitoring well #4 in the foreground (orange). The monitoring well in the background (brown) is no longer used due to structural issues with the well tube and has been abandoned.

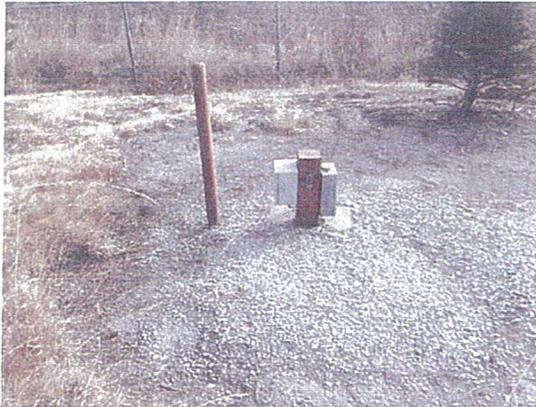
Ground Water Monitoring Well #2 identified in the previous annual inspection report as having a significant crack in the concrete pad was repaired by pouring a new pad (see Photograph #10). Notification of this repair was made to NDEQ in a letter dated April 26, 2016.

Photograph #10 1/4/17
Photograph showing ground water monitoring well #2 with a newly poured concrete pad. The concrete pad was previously cracked and in need of repair.
