# Annual CCR Unit Inspection Report

Lon D. Wright Power Plant  
Fremont, Nebraska

Prepared for  
**Fremont Department of Utilities**

February 28, 2018

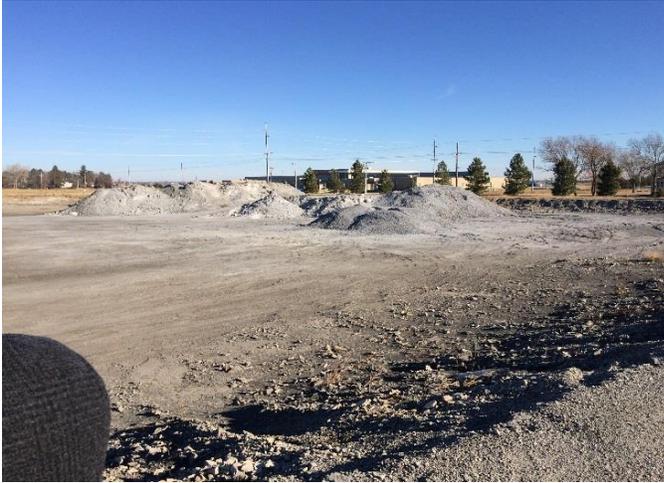
18-Dec-17  
Photograph #1

Photograph of CCR Unit Phase 1 facing northeast on access road between CCR Unit disposal area and leachate pond.

Piles of CCR are staged for off-site shipment for beneficial use.

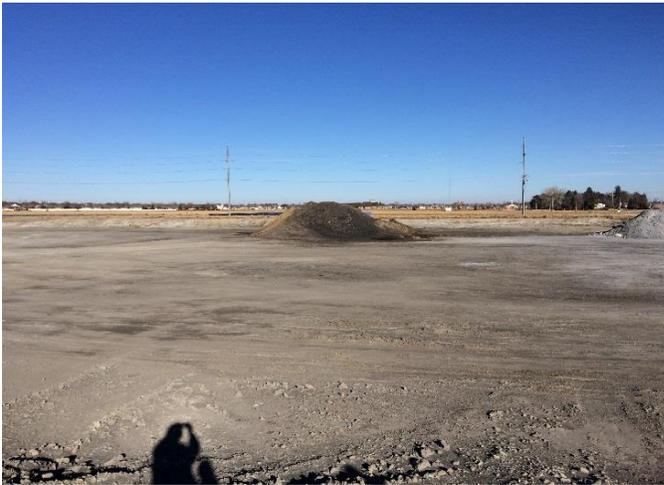
18-Dec-17  
Photograph #2

Photograph of CCR Unit Phase 1 facing northwest on access road between CCR Unit disposal area and leachate pond.

View of bottom ash pile.

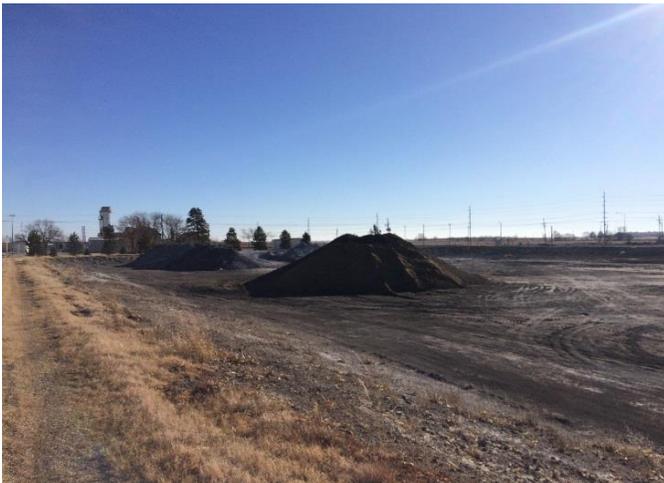
18-Dec-17  
Photograph #3

Photograph of CCR Unit Phase 1 facing east, southeast from southwest corner of berm.

View of bottom ash with fly ash in background.

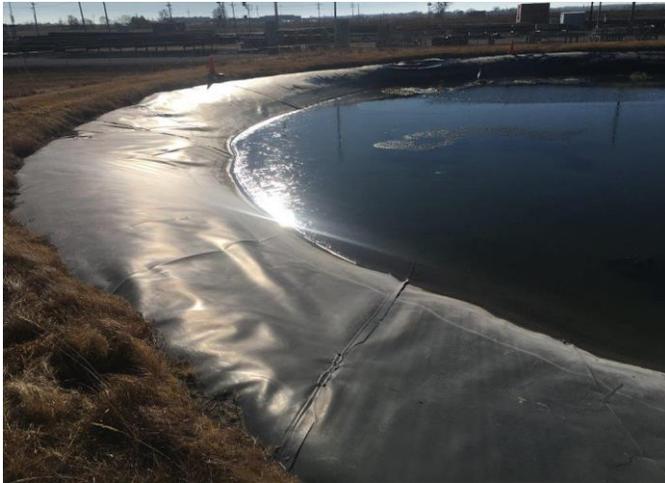
18-Dec-17  
Photograph #4

Photograph of east end of  
leachate pond and liner.

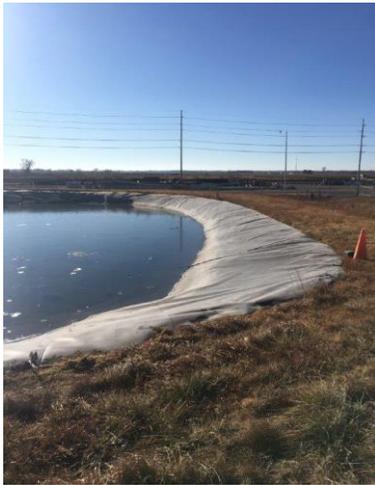
18-Dec-17  
Photograph #5

Photograph of west end of  
leachate pond and liner.

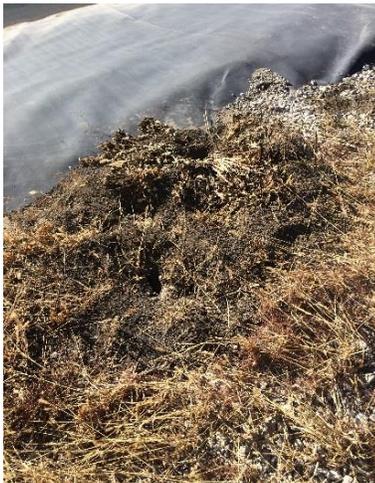
Evidence of rodent activity was observed near the pump house. Shallow rodent burrow holes were observed, but had not caused damaged or otherwise affected the leachate pond liner. Rodent bait traps were strategically placed in this area. Tony Sedlacek explained that the bait traps were routinely managed and that no damage to the liner or other leachate collection system equipment was observed during the annual period.

18-Dec-17  
Photograph #6  
Photograph of shallow  
rodent burrows above the  
liner near the pump house.

*Recommendations: FDU should continue to be diligent about eradicating pests that have the potential to cause damage to the leachate collection system. No conditions were observed that indicated any structural weakness, change in geometrical design, or a disruption in operation and safety of the leachate collection system. Additionally, FDU should continue to be diligent in meeting the leachate system requirements including conducting camera inspections of the leachate system piping.*

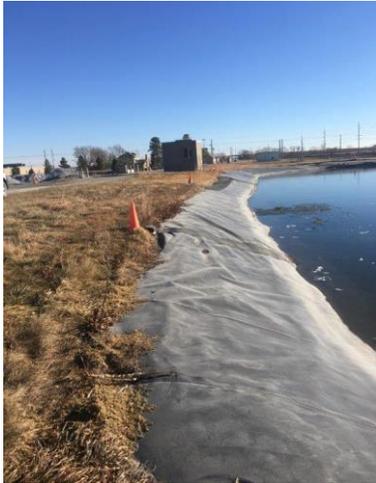
18-Dec-17  
Photograph #7

Photograph of the north side of the leachate pond and liner with the pump house in background (center),

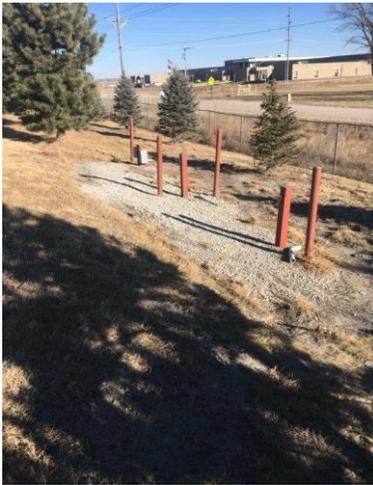
18-Dec-17  
Photograph #8

Photograph of Monitoring Well #1 ("MW-1") located east of the CCR Unit.

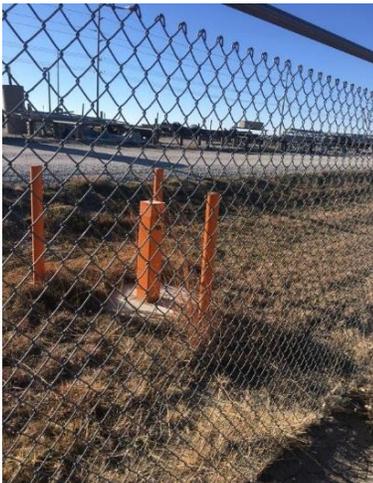
18-Dec-17  
Photograph #9

Photograph of Monitoring Well #8 ("MW-8") located south of the leachate pond.

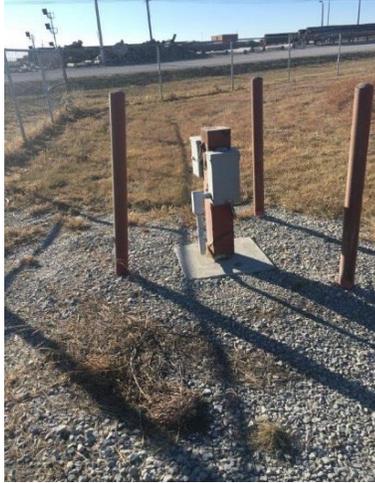
18-Dec-17  
Photograph #10

Photograph of Monitoring Well #3 ("MW-3") located southwest of the leachate pond.

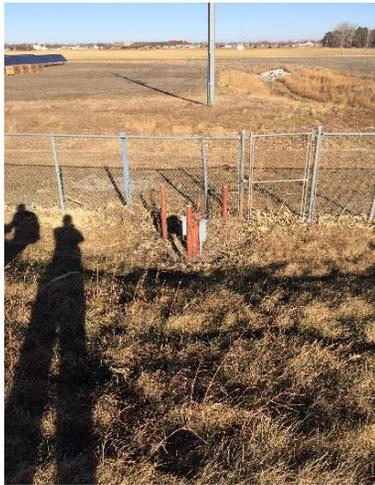
18-Dec-17  
Photograph #11

Photograph of Monitoring Well #5 ("MW-5") located north of the CCR Unit disposal area.

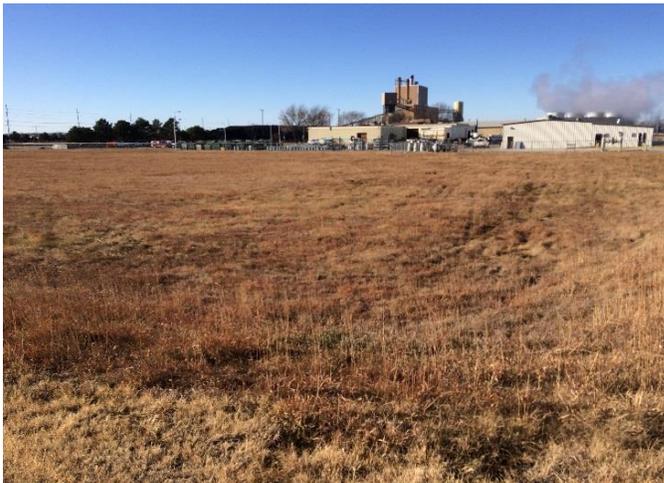
18-Dec-17  
Photograph #12  
Photograph of the undeveloped Phase 2 area identified for future use.
