**CITY COUNCIL RETREAT**  
**January 30, 2016**  
**City Council Chambers 400 East Military, Fremont NE**  
**START TIME – 8:00 A.M.**

# Fremont City Auditorium

#### B. Facility Condition Assessment

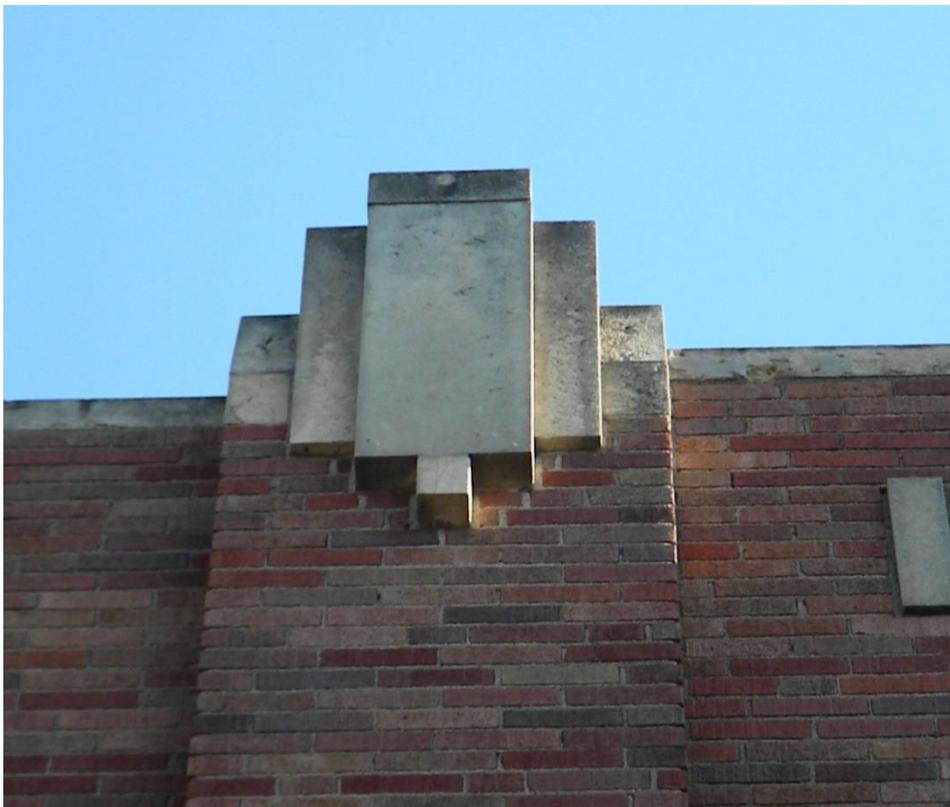
Photo A5

<b><u>Exterior Closure – B20</u></b>	
	<b>Exterior Walls – B2010</b>	
	<b>Exterior Wall Construction – B2011</b>	<b>Conc trim</b>
	Existing exterior wall construction is generally face brick with concrete trim and concrete inset details. Concrete trim locations include wall base, wall openings at sills, concrete trim as insets in field of brick at upper wall, and decorative trim at top of wall. Generally good condition in that no face brick, as well as no concrete trim units, require full unit replacement. Some patching and crack repair is required for the concrete trim base, exterior corners in particular, as some shearing of concrete face is occurring. See <b>Photo A4</b> .	<b>\$6,500.</b>
S	Concrete trim should be carefully cleaned, minor repair, caulking at existing joints. Brick should be cleaned, and brick joint tuckpointing is required, as is to be expected with a building of this age. See <b>Photos A5 and A6</b> .	<b>Brick clean</b>

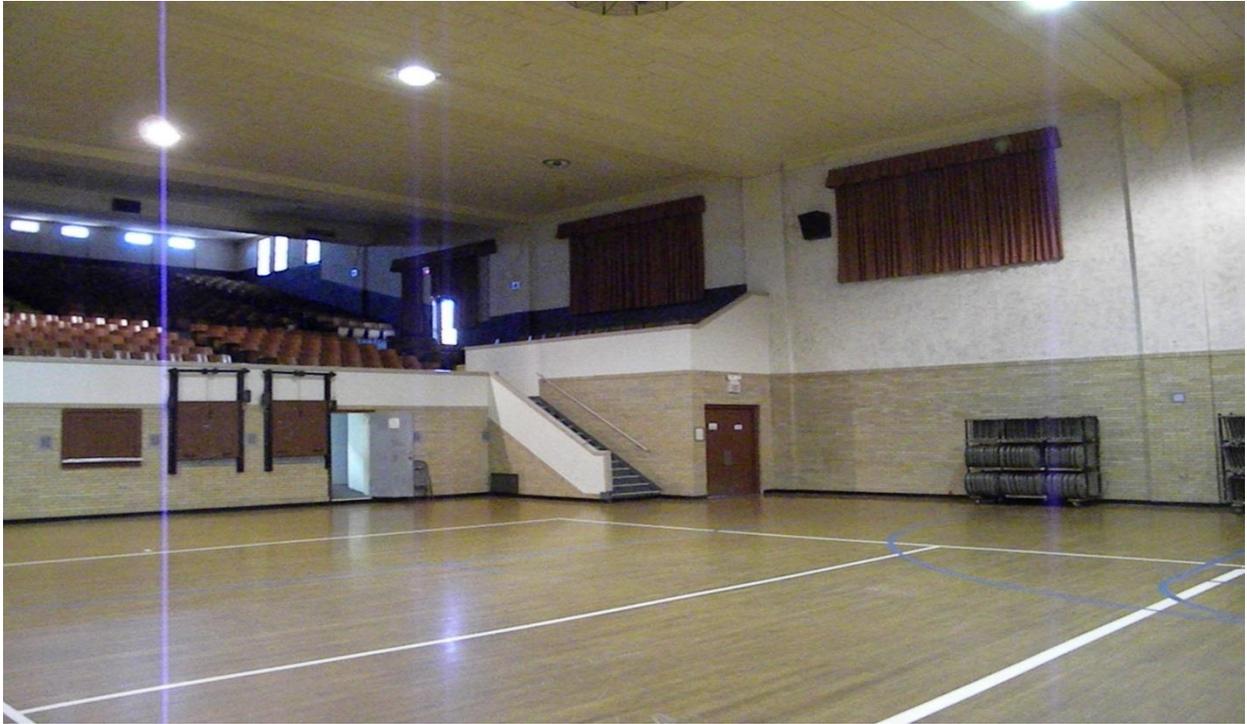
Photo A14

Priority	UniFormat Element	Cost
M	<p>Auditorium area plaster walls and brick walls are in good condition. See <b>Photos A14, A20, and A21</b>. Clean, prep, and paint plaster walls.</p>	
S	<p><b>Floor Finishes – C3020</b>  <b>Flooring – C3024</b>  Auditorium wood floor requires refinishing, or replace with another floor finish as appropriate for a community use rental hall. See <b>Photos A20 and A21</b>.</p>	
S	<p>Kitchen- replace red quarry tile floor. See <b>Photo A22</b>.  Balance of finished spaces- remove existing carpet or tile floor with new finishes. See <b>Photos A23, A25, A26</b>.</p>	
M	<p>Existing terrazzo flooring at Lobby and Foyer is in good condition. Requires cleaning.</p>	
S	<p><b>Ceiling Finishes – C3030</b>  <b>Ceiling Finishes – C3031</b>  Auditorium – install new suspended acoustic tile ceiling system. In areas above the balcony seating, replace existing acoustic tile with new suspended tile system. See <b>Photo A24</b>.</p>

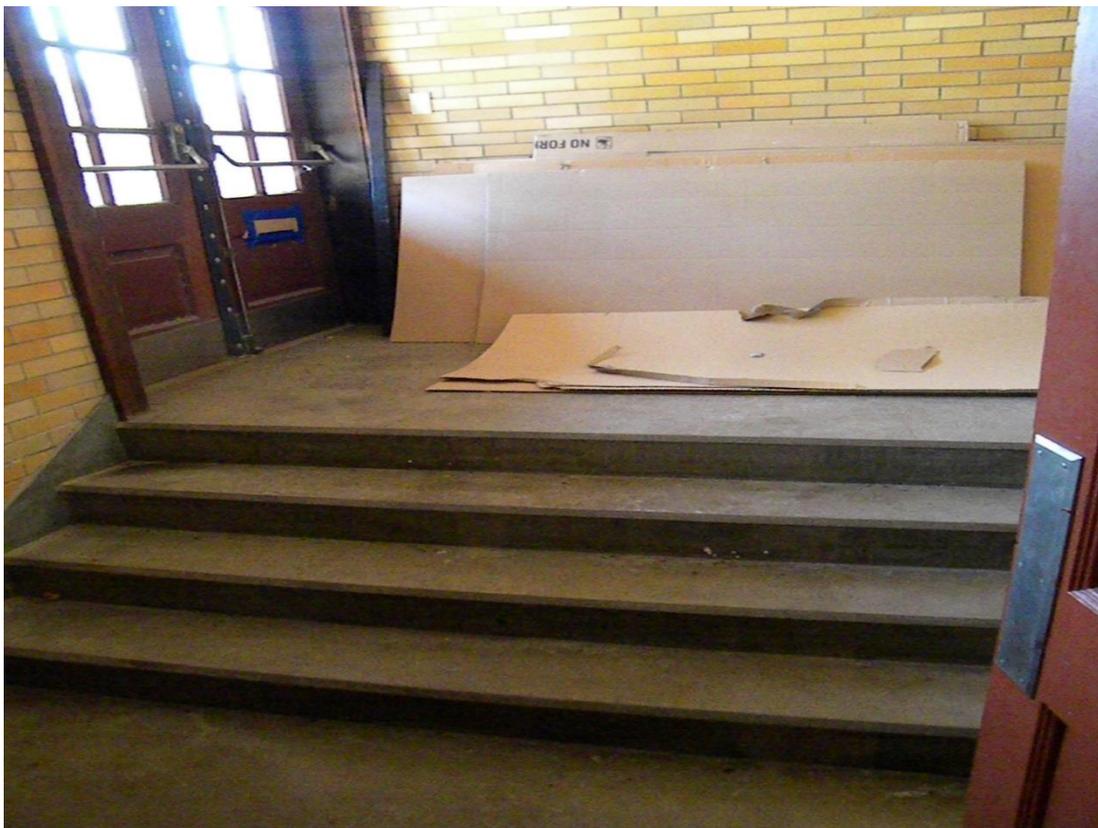
Photo A15

Priority	UniFormat Element	Cost
S	<p><b>Interior Doors – C1020</b>  <b>Interior Doors/Frames/Hardware – C1021</b>  Many doors that have not already been replaced have original hardware. See <b>Photo A15</b>. Hardware should be replaced.  Clean prep, and paint all existing painted doors and frames.</p>	
M	<p><b><u>Stairs – C20</u></b></p> <p><b>Stair Construction – C2010</b>  <b>Stairs – C2011</b>  Interior stairs are in good condition.  <b>Stair Handrails – C2014</b>  Stair handrails do not meet current codes, or are non-existent. However, due to this being a historic structure, the handrails are allowed to continue as they exist today unless the code Authority Having Jurisdiction judges this to be a dangerous condition. See <b>Photos A15 and A16</b>.</p> <p><b>Balcony railings – C2016</b>  The existing concrete tiered auditorium balconies have low walls in lieu of front guardrails and do not meet current codes regarding height. See <b>Photos A17 and A18</b>. However, these tiered auditorium seats are no longer used. The low walls would need additional railings added to them if this is judged to be a dangerous situation by the code Authority Having Jurisdiction.</p>

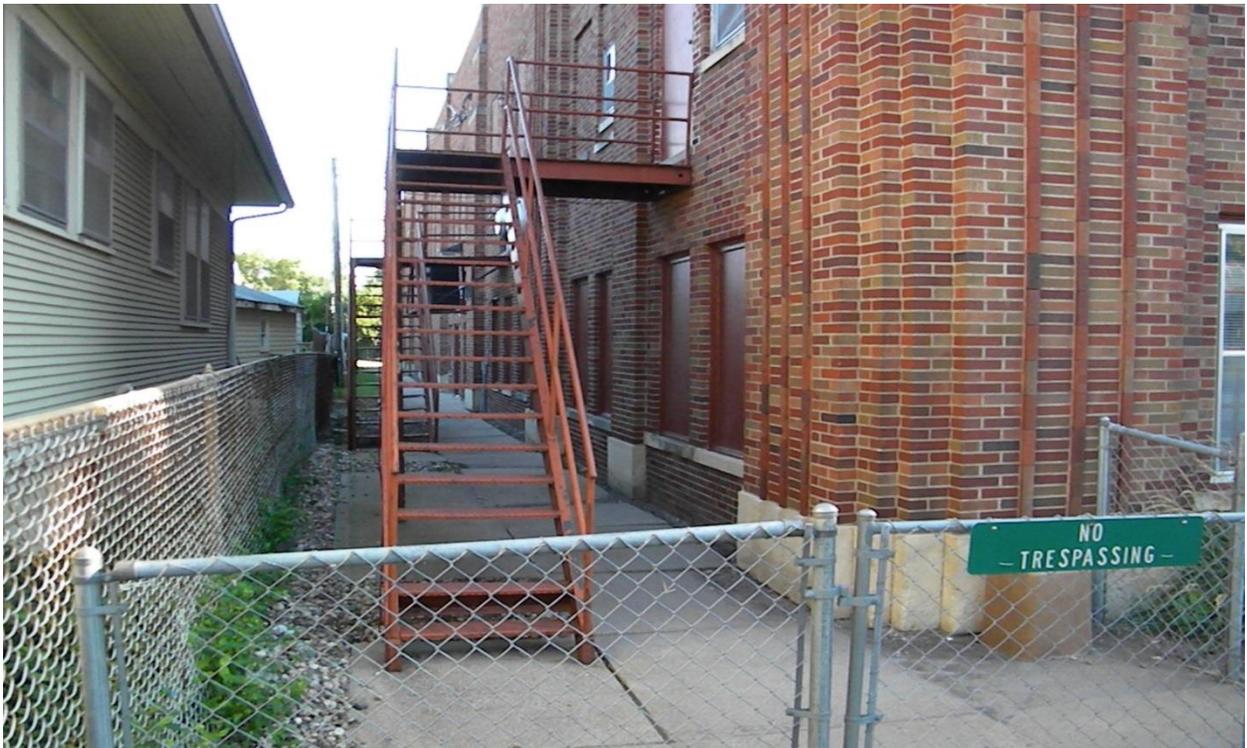
Photo A19

M	<p><b>Exterior Fire Escape Stair – C2018</b>  Good condition structurally. Should be cleaned, prepped, painted. See <b>Photo A19</b>.</p>	
S	<p><b><u>Interior Finishes – C30</u></b></p> <p><b>Wall Finishes – C3010</b>  Wall Finishes to Interior Walls – C3012  Install new walls to close off stage area from Auditorium to the general public. Inset to allow view of existing plaster Art Deco wall detailing. See <b>Photo A21</b>.</p>

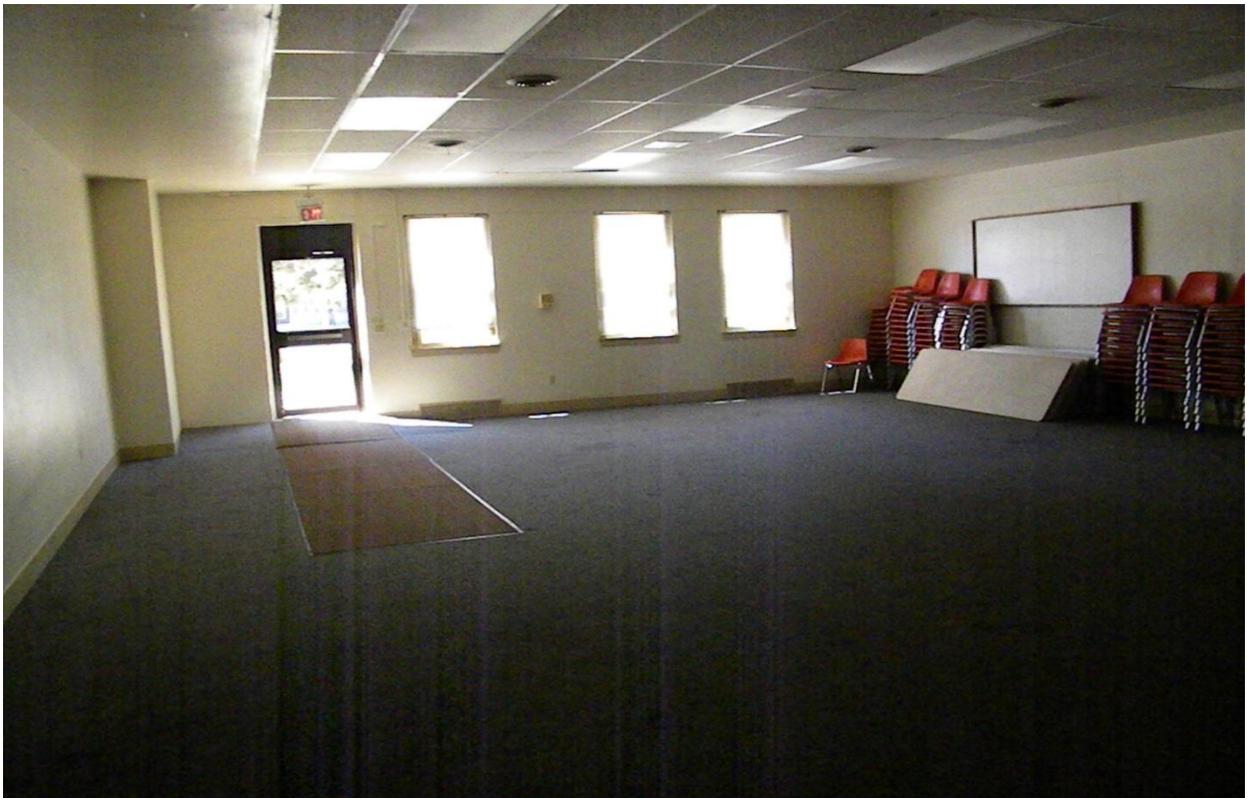
Photo A25

S	<p>All spaces, replace existing ceilings with new acoustic tile systems. See <b>Photo A25</b>.</p>	
<p><b>BUILDING, GENERAL CONSTRUCTION</b></p>		<hr/> <p><b>\$ 1,121,400</b></p>
<p><b>Plumbing – D20</b></p>		
M	<p><b>Plumbing Fixtures – D2010</b>  Existing Conditions:  Most of the existing plumbing fixtures appear to be in good working order. The shower facilities in the locker room do not appear to be used very often.</p> <p>As part of the recommended remodel, the main floor toilet facilities, central to the main floor area, will be remodeled and added to, to increase the capacity and conform to current accessibility requirements. See <b>Photos A26, A27, and A28</b>.</p>	<p><b>\$150,000</b></p>

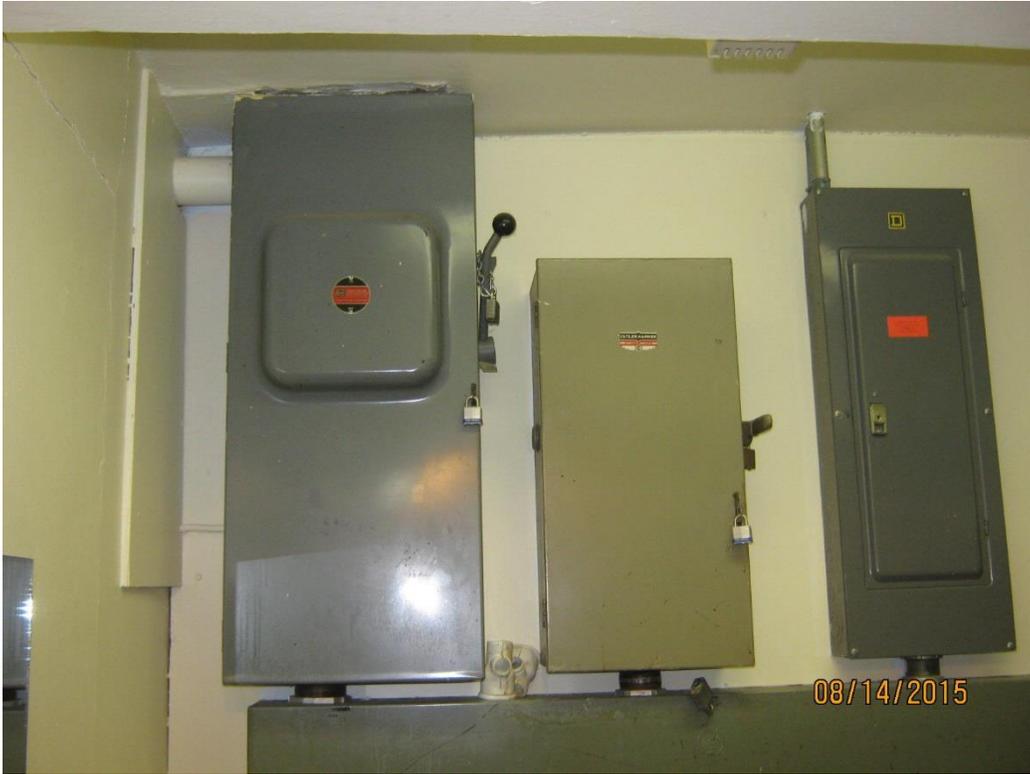
Photo E5

Priority	UniFormat Element	Cost
<b>S</b>	<p data-bbox="375 281 594 317"><b><u>Electrical – D50</u></b></p> <p data-bbox="375 359 971 432"><b>Electrical Service and Distribution – D5010 Service – D5012</b></p> <p data-bbox="375 480 634 516">Existing Conditions:</p> <p data-bbox="375 520 862 556">The Facility has a total of (3) services</p> <p data-bbox="375 560 878 596">Service 1 – north end – 480V; 3-phase</p> <p data-bbox="375 600 1218 753">This service is fed underground from pole mounted transformers; the panel does not have a single main – there are (4) breakers with loads and space for (2) additional breakers. Technically this service has (4) mains with space for (2) more. See <b>photo E1</b>.</p> <p data-bbox="375 758 1102 793">Service 2 – north end service – 120/240V; single-phase.</p> <p data-bbox="375 798 1224 911">This service is fed overhead from pole mounted transformers; the service panel was undetermined and therefore the number of mains is unknown. See <b>photo E2</b>.</p> <p data-bbox="375 915 1000 951">Service 3 – south end – 120/240V; single-phase</p> <p data-bbox="375 955 1174 1029">This service is fed overhead from pole mounted transformers; there appears to be one main disconnect. See <b>photo E3</b>.</p> <p data-bbox="375 1033 1229 1230">The service equipment is in fair to good condition. It is unusual for this number of services and at least 6 mains in this size of facility. Six mains are allowed by code. It there was a requirement to totally shut power off it would be easier for the power company to shut off primary power.</p> <p data-bbox="375 1234 631 1270">Recommendations:</p> <p data-bbox="375 1274 1235 1388">The electrical service should be replaced in its entirety. This would include a single point service entry with distribution to the different load points in the facility.</p> <p data-bbox="440 1434 725 1467"><b>Distribution – D5014</b></p> <p data-bbox="375 1472 634 1507">Existing Conditions:</p> <p data-bbox="375 1512 1224 1665">A 480 volt, 3-phase panel that is considered a service panel was installed for the HVAC upgrade. This panel is located on the west exterior of the building and feeds the 480V air-cooled condensers and through a step-down transformer feeds a 240volt panel.</p> <p data-bbox="375 1669 1239 1785">240 volt single phase panels are located on the stage area that feed loads at the stage and gym areas as well as the locker rooms below. See <b>photo E4</b>.</p> <p data-bbox="375 1789 1234 1902">Several additional panels, typically load centers, are located in the office, kitchen and community room areas and feed loads in their respective vicinity. Kitchen panels are located in the men’s</p>	<b>\$21,000</b>

Priority	UniFormat Element	Cost
S	<p>restroom. See photo E5.</p> <p>The electrical panels vary in age and condition. Original panels have all been replaced and some of those have been replaced a couple of times.</p> <p>Recommendations:</p> <p>The distribution should be upgraded in its entirety. The equipment would be fed from the new service equipment.</p>	<b>\$49,000</b>
M	<p><b>Lighting &amp; Branch Wiring – D5020</b></p> <p><b>Devices – D5021</b></p> <p>Existing Conditions:</p> <p>Devices for the most part are adequate for the operation of the building today. It appears GFI outlets are provided where required. Some areas depending on the activity intend a shortage and lack of placement due to the number of extension cords used that was observed during the site investigation.</p> <p>Recommendations:</p> <p>If the branch wiring is replaced the devices should be replaced as well. The convenience outlets should include tamper resistant type because of the number of children that may be at the facility.</p>	<b>\$12,000</b>
